TEST STAND DESIGN AND ANALYSIS FOR TITAN 34D STATIC FIRING¹

Shayan Pazargadi
Wyle Laboratories

The Test Stand 1C at the Air Force Astronautics Laboratory (AFAL), Edwards AFB, CA, was originally designed for F-1 liquid propellant engines. The stand was modified to handle a 5½-segment Solid Rocket Motor (SRM) Titan 34D vertical static firing test. The new configuration is the only nozzle-down test stand of long SRM's in the United States, which had to withstand 6.2MN (1.4M pounds) thrust load, and 2444 KN (550 Kips) rocket weight, as well as seismic and wind loads. The 3230 cm (106 feet) high stand was made of stainless steel truss system supported by a massive reinforced concrete foundation. The vertical and lateral thrust loads were mainly resisted by a four-legged pylon structure attached to the test stand and foundation. A superstructure was designed to house the rocket and provide working platforms for stacking operations. Several finite element models of the combined test stand-pylon-rocket were developed on ANSYS, NASTRAN and IMAGES-3D softwares. The models were analyzed for a variety of static, dynamic and transient loads to ensure the structural integrity of the test stand

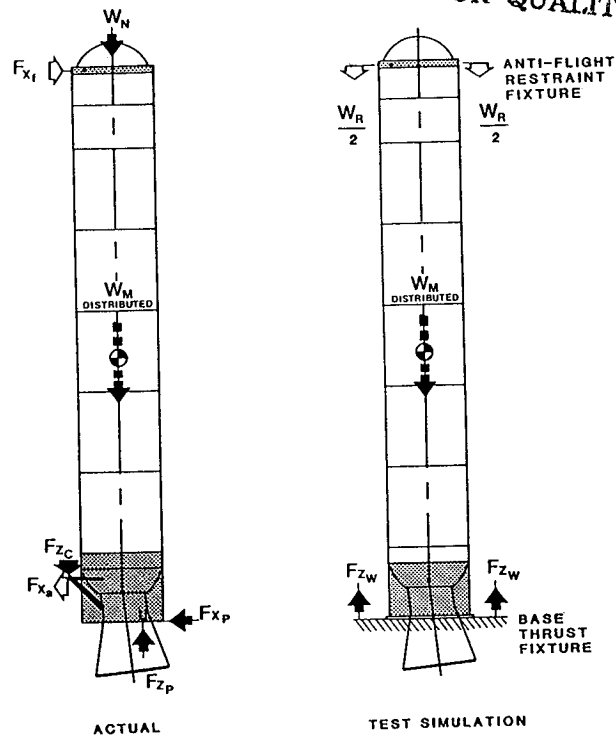
FIGURE 1. COMPARISON OF THE LOAD RESTRAINT SYSTEM BETWEEN ACTUAL AND TEST SIMULATION - PREFIRE

- o There were no requirements for thrust vector control or axial thrust measurement
- o The aft stub skirt was able to react the total thrust with an adequate margin of safety
- o Lateral thrust loads resulting from the 6° nozzle cant could be reacted through the aft stub skirt interface tooling
- o Motor case and joint loads induced by motor pressurization during firing were considerably in excess of those resulting from externally applied loads, so it was not necessary to simulate external loading conditions.

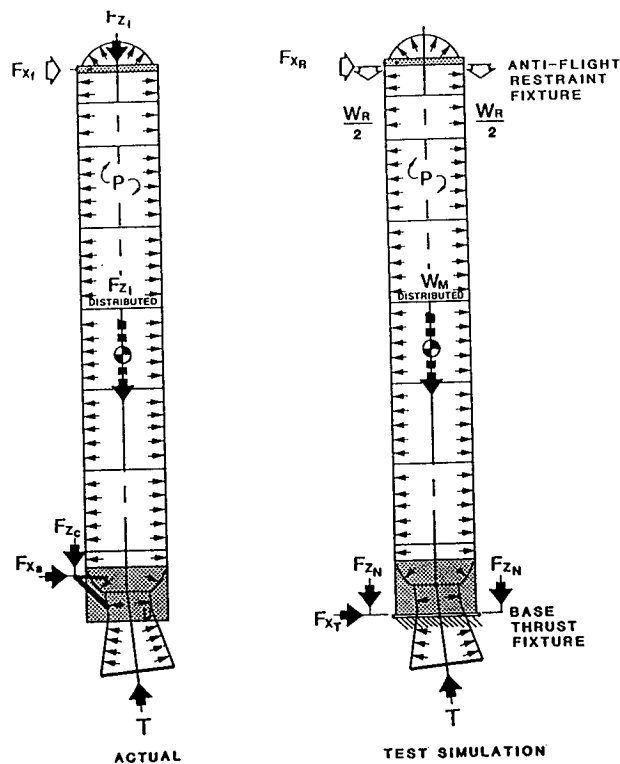
FIGURE 2. COMPARISON OF THE LOAD RESTRAINT SYSTEM BETWEEN ACTUAL AND TEST SIMULATION - POST LIFTOFF

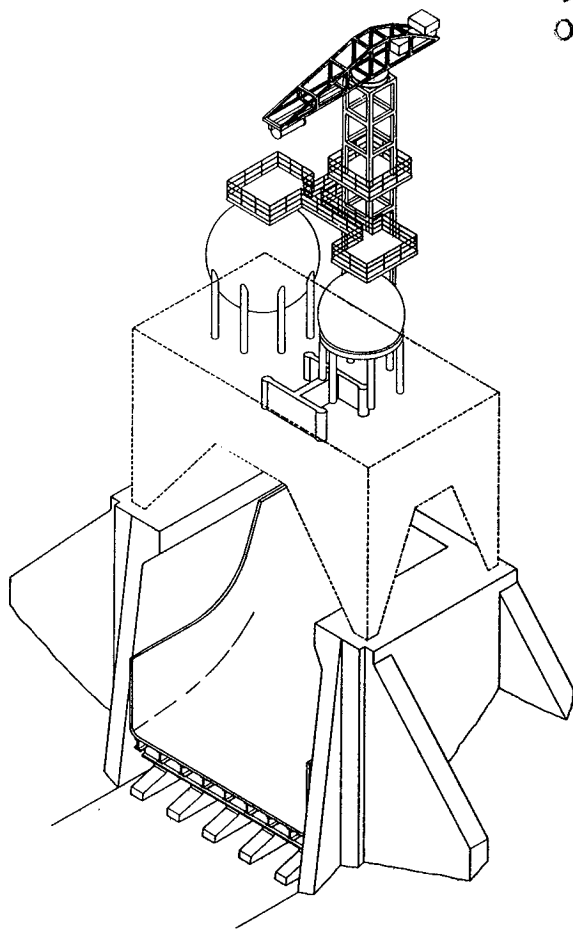
FIGURE 3. ORIGINAL TEST STAND

The Test Stand 1C was originally designed for liquid rocket engines and was configured for the Rocketdyne F-1 engines with 305 cm (120 in.) diameter and 406 cm (160 in.) long and a thrust force of 6.67 MN (1.5 Mlb) on liquid oxygen/RP-1 fuel. The engine was supported on a four-legged pylon which could support vertical upward loads of up to 35.56 MN (8 Mlb) and horizontal loads of 4.44 MN (1 Mlb).

The following modifications were made to the original stand (Fig.3) to adapt to the new requirements of Titan 34D static firing tests on the modified stand (Fig.4):

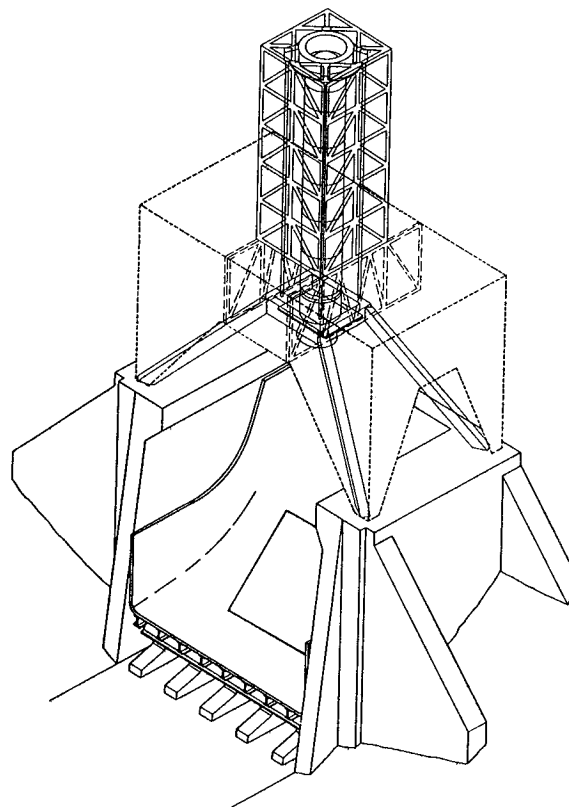
FIGURE 4. MODIFIED TEST STAND

- plumbing between the tanks
 - Firex piping
 - engine mount and thrust measuring H-beam
 - tank support columns
- o Superstructure of K-type A36 steel frame added to the existing stand. The superstructure was to provide wind protection to the motor, fixed and removable platform for stacking operations and lateral restraint at the forward ring attachment at the 1463 cm (48 feet) level above the existing stand.

Finite element analyses of the modified test stand were performed to ensure the structural integrity of the new design concept. Preliminary finite element analysis of the existing stand had been performed by IMAGES-3D structural code (Fig. 8). Trusses T-4 and T-5 (also shown in Fig. 4) are the main load carrying members of the existing stand to support the superstructure weight of 411 KN (92.5 Kips). The structure would reach its yield condition at a vertical load of 711 KN (160 Kips). Two of 12 WF members were found inadequate and were replaced by 24 WF 76 beams members. ANSYS and NASTRAN codes were used to model the test stand, the pylon and the motor. Three stand-pylon configurations were analyzed to obtain the most effective design concept:

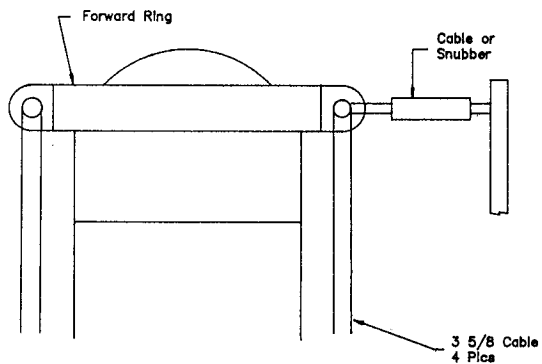
FIGURE 5. FORWARD END RESTRAINT SYSTEM

- o A forward ring (Fig.5) at the forward end of the motor that provided axial restraint through the anti-flight restraint cables and lateral restraint through snubber connection to the superstructure in both horizontal directions.

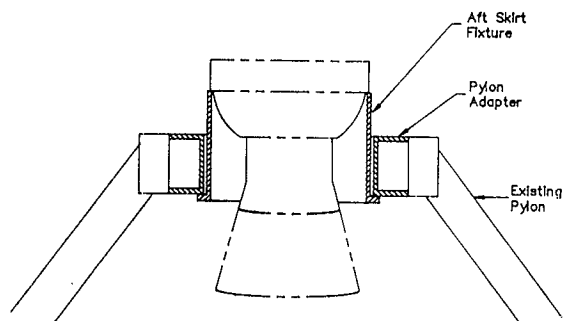
FIGURE 6. AFT END RESTRAINT SYSTEM

- o Pylon adaptor made of A36 steel and aft skirt fixture made of 4130 steel both designed to 44.4 MN (10 Mlb) vertical thrust load to provide interface between the pylon and the rocket aft end (Fig.6). The pylon adapter was designed to connect the existing rectangular pylon opening with the 305 cm (10 feet) diameter thrust cylinder. The aft skirt fixture was designed to provide the interface between the pylon adapter fixture and the motor aft stub skirt.

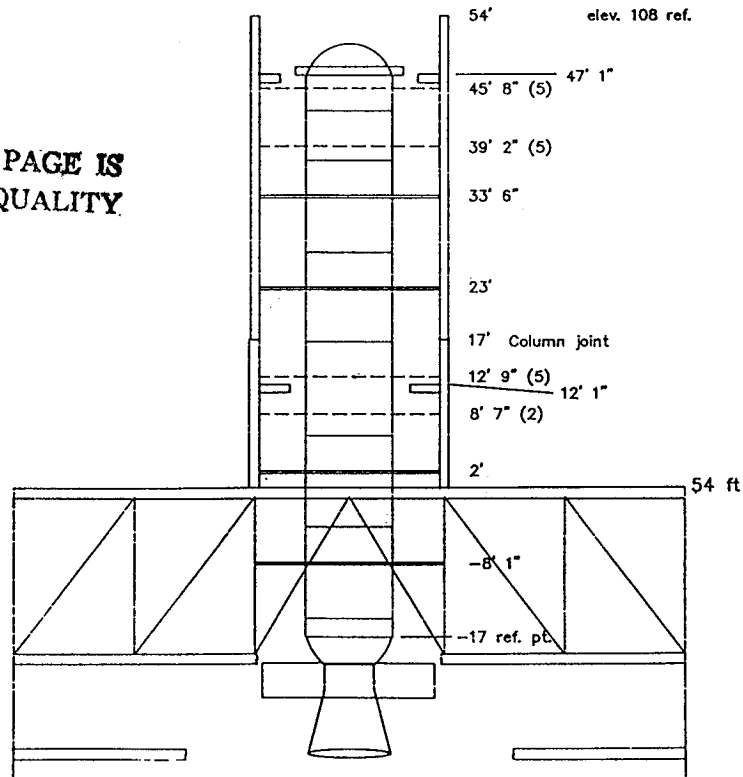
FIGURE 7. 5-1/2 MOTOR SEGMENT SETUP

- o A working platform was added at 244 cm (8 feet) below the top of the existing stand to support a 6800 Kg (15000 lb) x-ray machine. The 5½ segment setup and configuration of the platforms are shown in Figure 7.

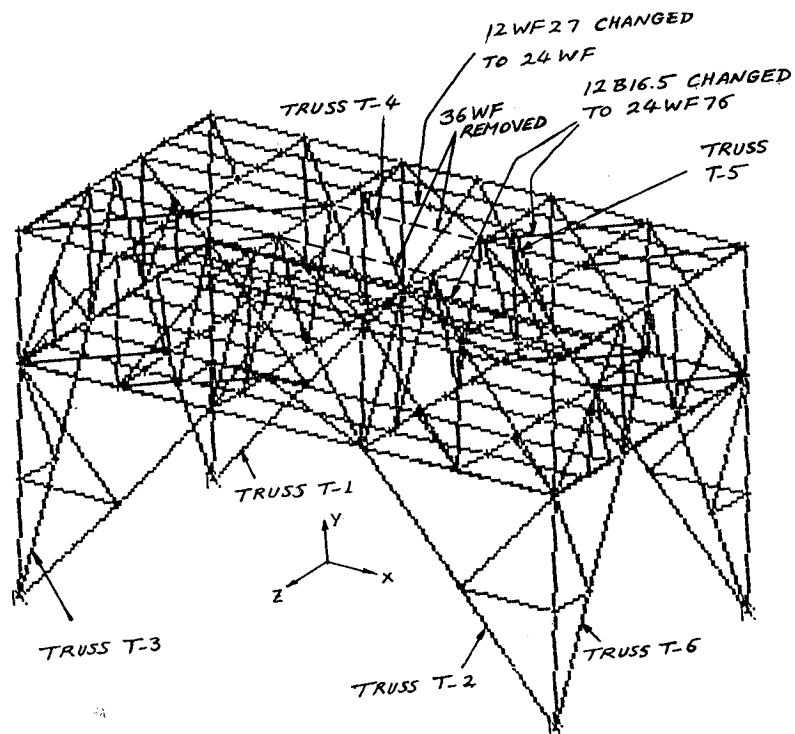
FIGURE 8. FINITE ELEMENT MODEL OF THE EXISTING STAND

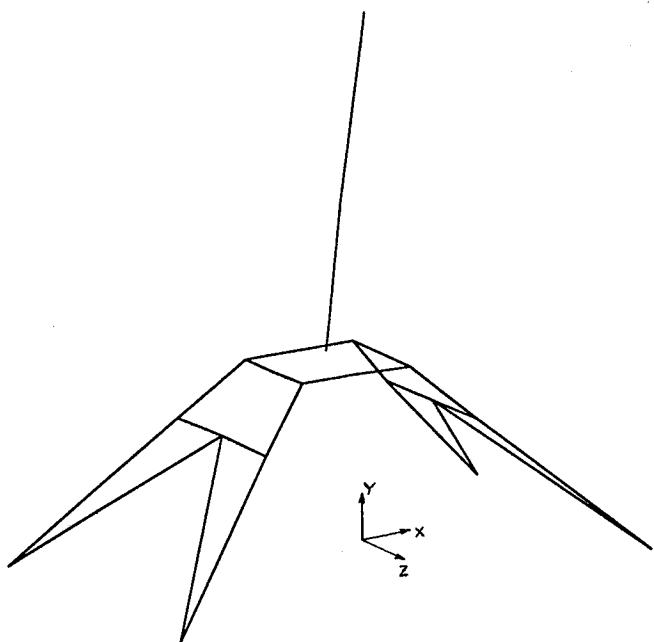
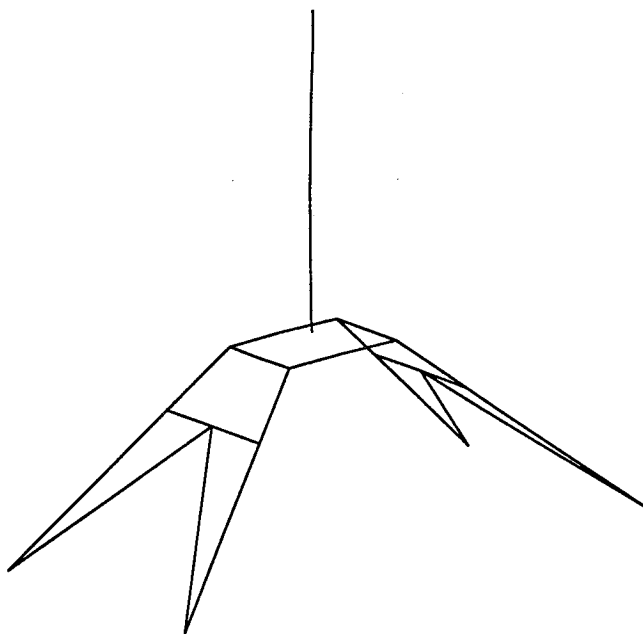
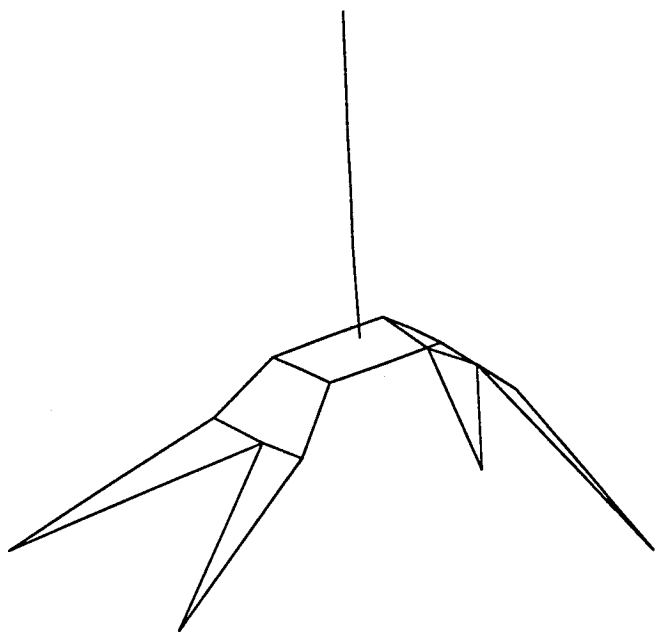
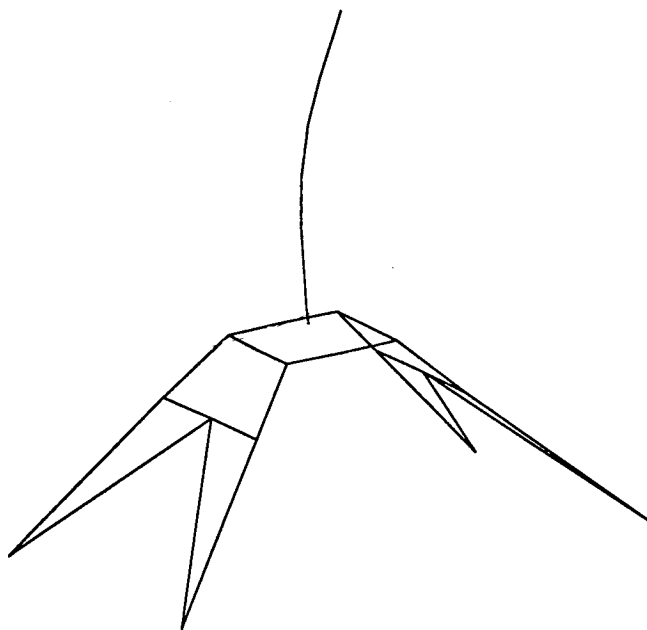
(A) MODE 1 - 1.16 Hz

(B) MODE 2 - 1.25 Hz

(C) MODE 3 - 5.99 Hz

(D) MODE 4 - 7.47 Hz

FIGURE 9. NATURAL FREQUENCIES OF THE PYLON-MOTOR ASSEMBLY

Dynamic analysis of the unattached configuration indicated fundamental frequencies of 1.16 Hz for the pylon-motor assembly and 3.89 Hz for the test stand. Concerns were made at the dynamic characteristic of the pylon motor assembly at such low frequencies (Fig. 9). The fundamental frequency increased to 2.51 Hz for configuration II and to 2.79 Hz for configuration III with the latter one being adopted as an improved design over the unattached or partially attached concepts. Natural frequencies of the completely attached configuration are shown in Table 1.

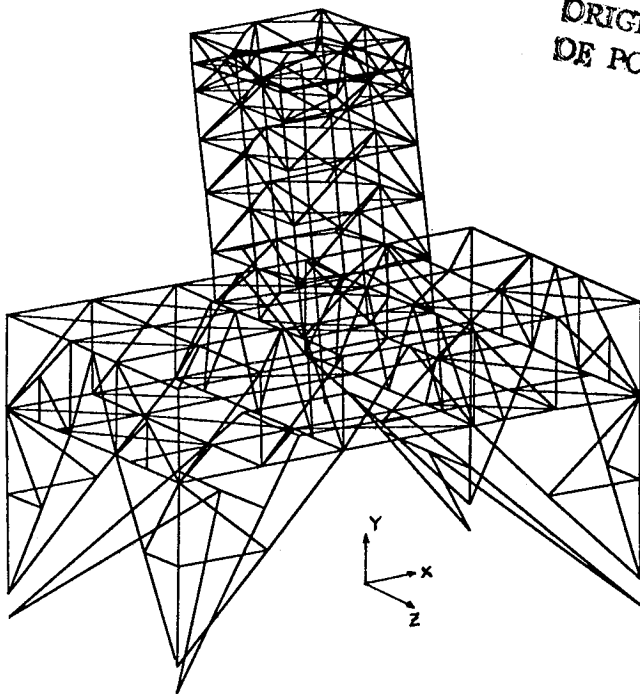
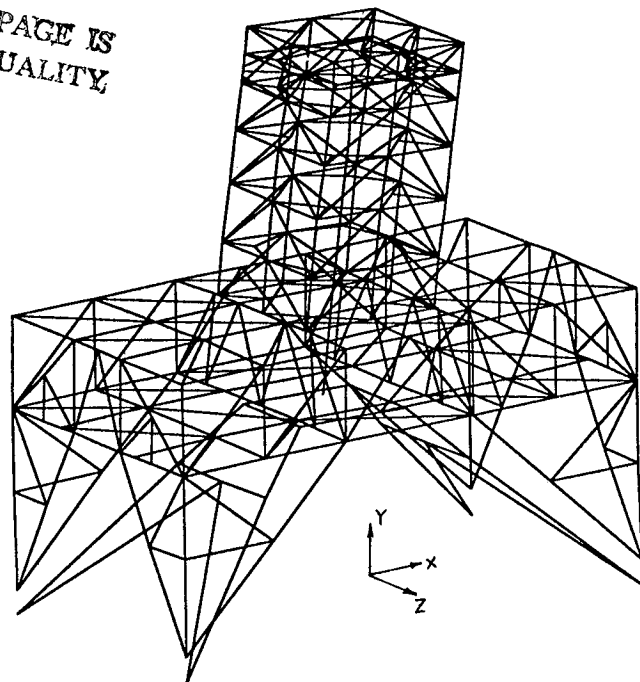
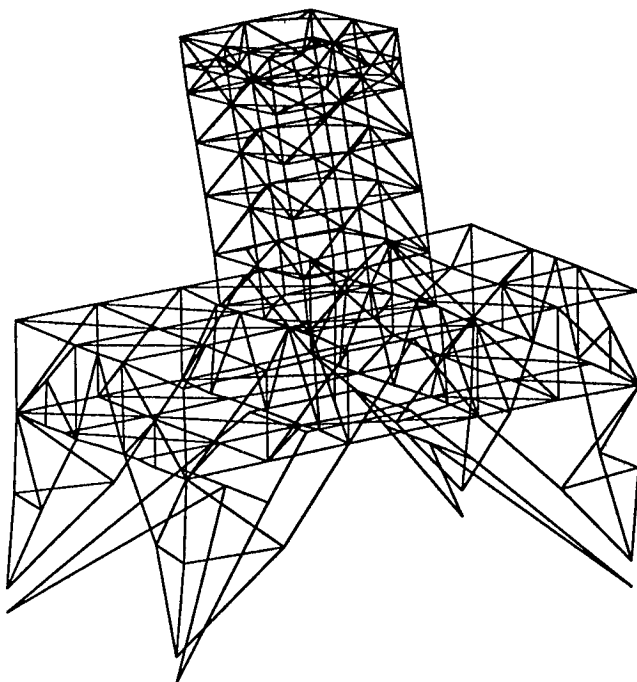
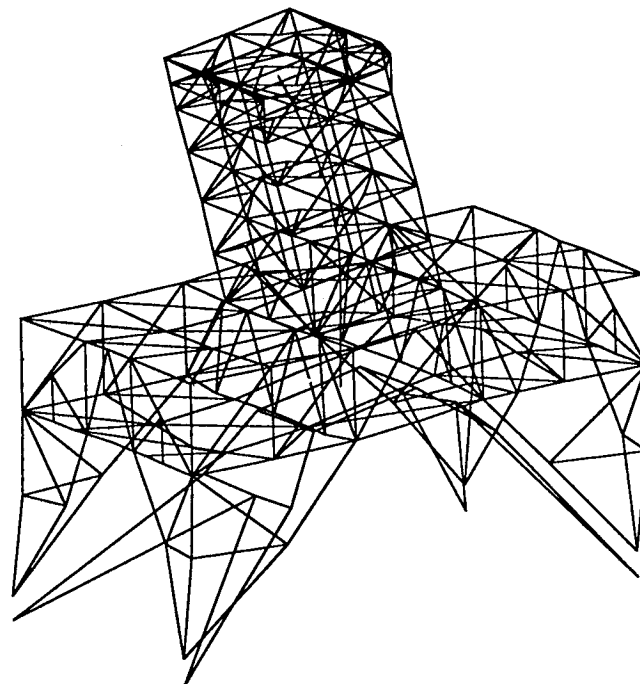
(A) MODE 1 - 2.79 Hz

(B) MODE 2 - 2.84 Hz

(C) MODE 3 - 7.09 Hz

(D) MODE 4 - 7.44 Hz

FIGURE 10. NATURAL FREQUENCIES OF THE COMPLETELY ATTACHED
STAND-PYLON-MOTOR ASSEMBLY

- o due to a much heavier and taller SRM with respect to liquid engines, resonance frequencies of the motor-pylon assembly will become a critical factor in the stability of the assembly under dynamic environments such as earthquake, wind and transient thrust loads. For this reason, the motor-pylon assembly had to be tied-in to the test stand at the pylon level and the motor forward end had to be attached to the superstructure. This tied-in configuration increased the fundamental frequency of the assembly by a factor of 2.4.

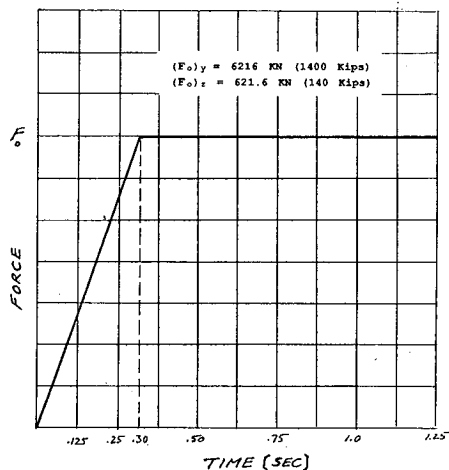
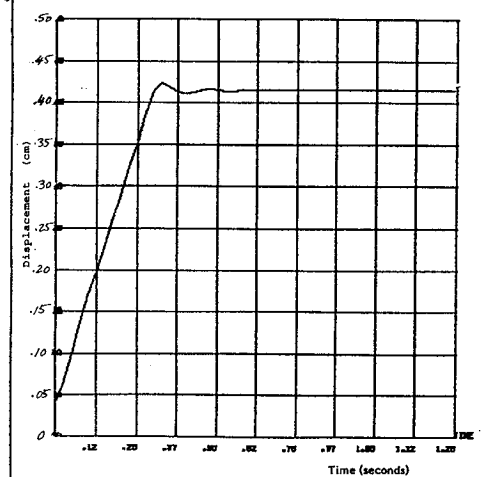
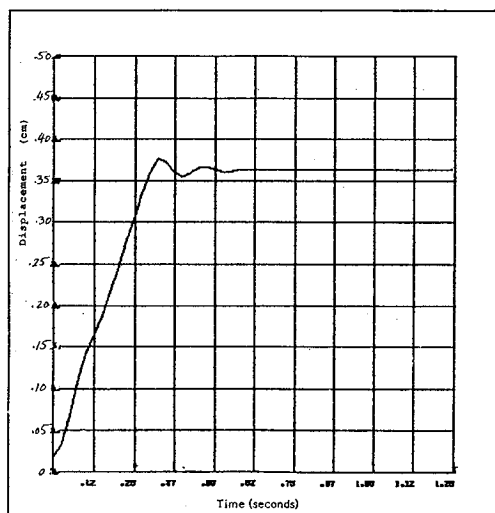
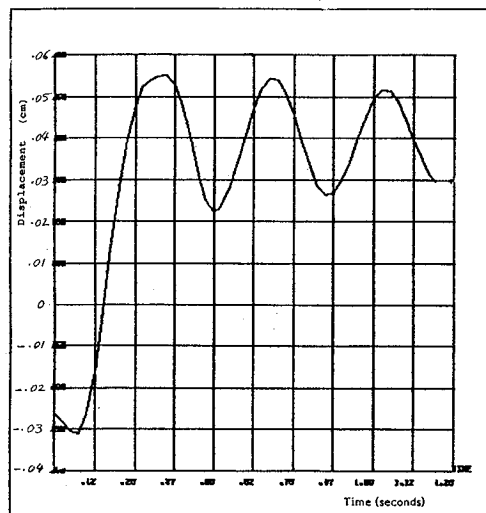
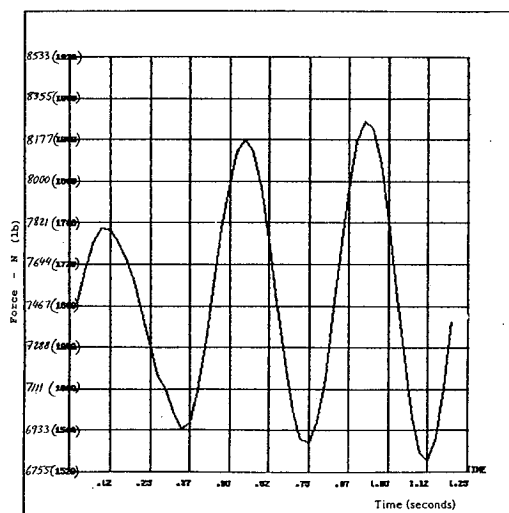
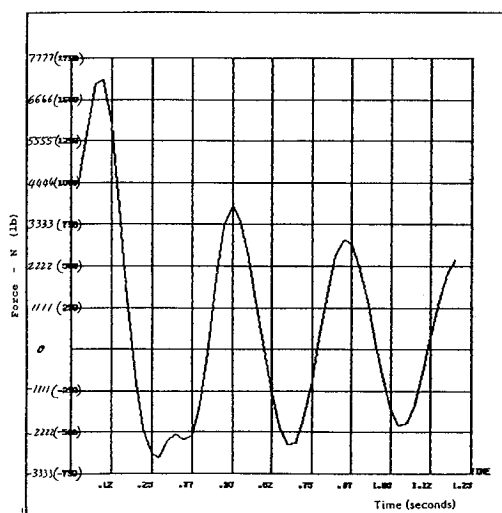
(A) IDEALIZED THRUST LOAD

(B) VERTICAL DISPLACEMENT AT THE BASE OF THE MOTOR

(C) VERTICAL DISPLACEMENT AT THE TOP OF THE MOTOR

(D) LATERAL DISPLACEMENT (Z) AT THE TOP OF THE MOTOR

(E) LATERAL FORCE (X) IN THE FORWARD END UNISTRUT

(F) LATERAL FORCE (Z) IN THE FORWARD END UNISTRUT

FIGURE 11. TIME HISTORY RESULTS DUE TO THRUST LOADS

The SRM thrust profile was enveloped to a ramp function reaching its peak of 6.2 MN (1.4 Mlb) at 0.30 seconds and staying flat up to 120 seconds at burnout.

Transient behavior of the stand was studied for the first few seconds after the start of firing. A maximum overshoot of 25% was observed in the displacement responses at 0.3 second, when the thrust force reached its peak, but it quickly damped out to its stationary value after one second from the start of firing. Transient responses of displacements and forces at the top and bottom of the motor are shown in Figure 11. A stress factor of safety of better than 3 was obtained under different stages of the thrust load.
